UNITED STATES DISTRICT COURT  
SOUTHERN DISTRICT OF CALIFORNIA

Case Number Case No. C 07cv2107  
MMA

**DECLARATION OF DR. ROBERT  
N. ANDERSON IN SUPPORT OF  
PLAINTIFFS' MOTION FOR  
LEAVE TO SUPPLEMENT  
EXPERT DISCOVERY AND IN  
SUPPORT OF OPPOSITION TO  
DEFENDANTS' MOTIONS FOR  
SUMMARY JUDGMENT AND  
RELATED MOTIONS**

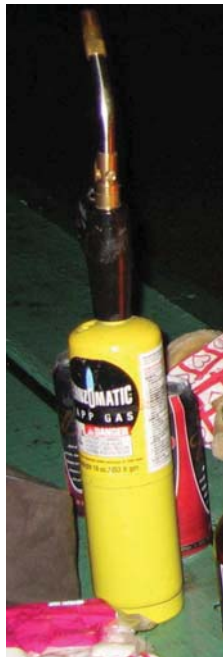
4 2. I have been retained to examine all available evidence and testimony and  
5 provide an expert opinion as to the cause of the breach of a Bernzomatic-brand MAPP  
6 gas cylinder and torch, which caused Plaintiff’s injuries on April 21, 2006. A photo  
7 of the actual MAPP gas cylinder and torch causing Plaintiff’s injuries, taken before  
8 the accident, was provided to me and is shown in fig. 1 below.

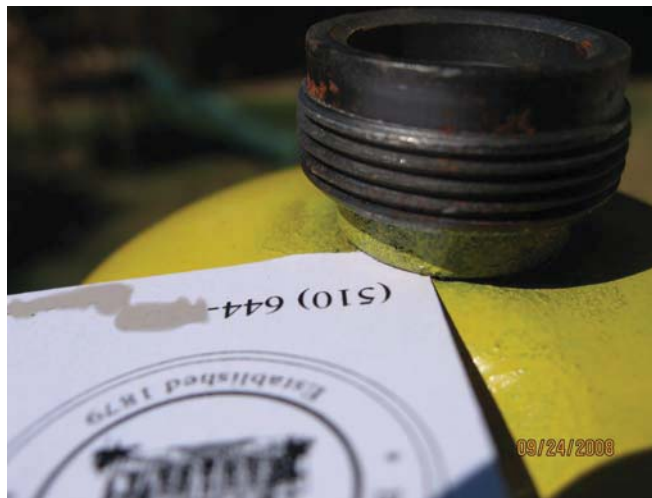
20  
21 3. Based on the preliminary information provided, there was reason to  
22 suspect that the brazed “bushing” of the subject cylinder had failed. The “bushing”  
23 as referenced herein is the threaded assembly welded on top of the cylinder, as shown  
24 in fig. 2 above, at the area of insertion of the card. The area of insertion of the card  
25 shows the area of defect on an exemplar purchased in September 2008.

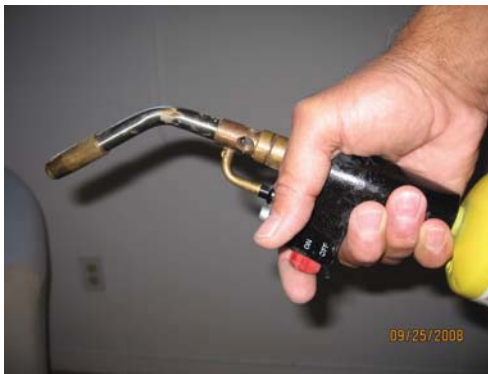
8  
9  
10  
11  
12  
13  
14 fig. 3

1 Bernzomatic MAPP gas cylinder which had caused his injuries on April 21, 2006.  
2 Mr. Shalaby also revealed to me that his right index finger had not been substantially  
3 injured, indicating that his earlier belief that he may have been holding the cylinder  
4 by the torch handle and depressing the button at the time of the explosion could not  
5 have been correct. I observed this to be the case, because his index finger as shown  
6 in fig. 3 below would have rested directly over the area of the breach, fig. 4 (from an  
7 exemplar), and would have been badly injured..

6  
7 (a) The observations of figures 3 and 4 above indicate Mr. Shalaby could  
8 not have held the cylinder / torch assembly by the torch handle at the  
9 time of explosion because his index finger did not sustain any significant  
10 injuries.

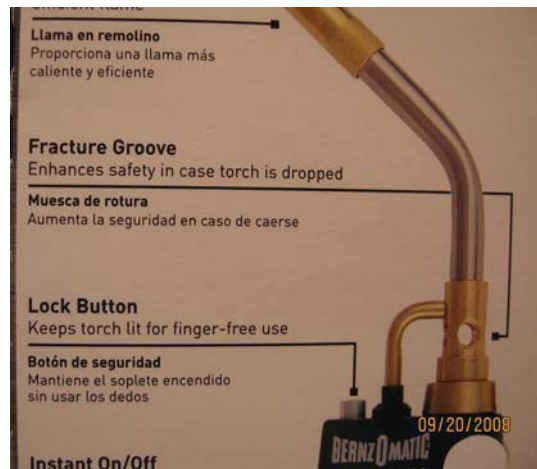
21  
22 fig. 5

15 Mr. Shalaby brought to my attention the existence of a safety “fracture groove”  
16 located on the Bernzomatic TS4000 torch handles such as the one Mr. Shalaby was  
17 using at the time of his injuries. Mr. Shalaby provided me with a package insert  
18 accompanying his purchase of a TS4000 torch and cylinder kit a few days earlier. The  
19 insert explains the fracture groove and its intended purpose, as shown in fig. 5 below.  
20

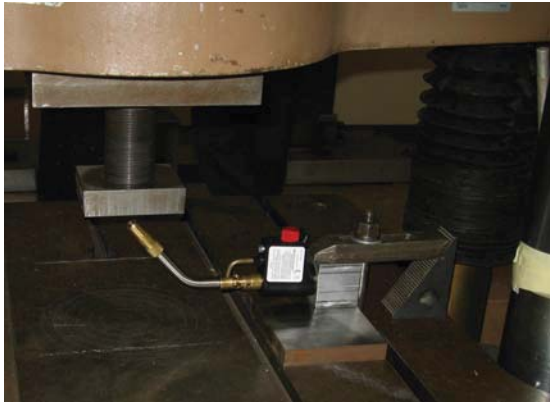
13 fig. 6

1 5. To confirm Mr. Shalaby's recollection of events, and further investigate  
2 based on the above observations, on September 26, 2008 I performed stress tests on  
3 three TS4000 torch handles, and on the "bushing" of a new Bernzomatic MAPP gas  
4 cylinder. The torch handles were tested on a machine measuring the amount of force  
5 required to fracture the fracture grooves, as shown in figure 6 below:

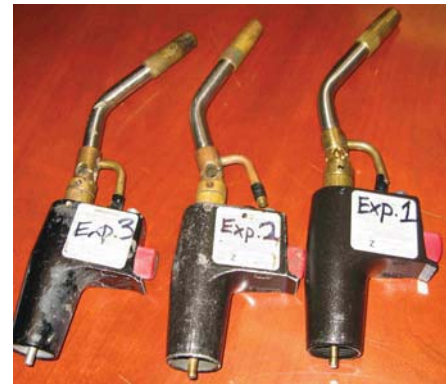
14 fig. 7

15 The fracture grooves of the two torch handles fractured at 22, 23, and a third torch  
16 handle utilizing a reduced-thickness fracture area (a re-design of approximately June  
17 2005) fractured at 26 foot-pounds (fig. 7, re-design shown as "Exp. 1").

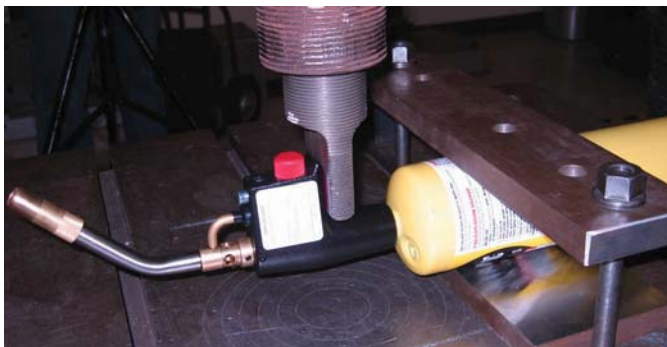
27 fig. 8

18 6. Next, we tested the amount of force required to cause a fracture or  
19 separation at the bushing by applying force at the torch handle, below the fracture line,  
20 as shown in fig. 8.

1 2 on page 2). A force of 152 pounds was applied directly to the torch handle, below  
2 the fracture groove (fig. 8). The cylinder bushing (valve) began to bend at 15 foot-  
3 pounds of force, and bent as shown in fig. 9, but did not breach or separate.

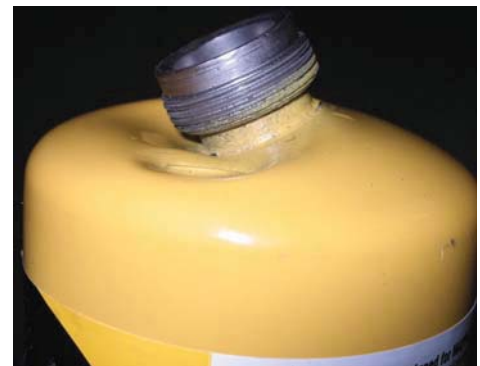
28 fig. 9

The cylinder used was one evidencing no defects at the bushing (compare fig. 9 to fig.

- 1  
2  
3  
4  
5  
6  
7  
8  
9  
10  
11  
12  
13  
14  
15  
16  
17  
18  
19  
20  
21  
22  
23  
24  
25  
26  
27  
28
- (d) Consistent with the fact that the subject cylinder was not bent at the “dome” in the manner shown in fig. 9 (as opposed to at the “separation” bends shown in figs 10 and 11 above), the force applied to the tip of the torch handle Mr. Shalaby was using at the time of his injury was well below 15 foot-pounds (absence of bending means force was below 15 foot-pounds).

21 therefore “greater than” 26 foot-pounds. The absence of a bend at the dome area (see  
22 fig. 9) establishes the force could not have exceeded 15 foot-pounds. In this instance  
23 the separation occurred at an estimated 3 foot-pounds or less. The absence of any  
24 evidence impact to the torch handle, and the fact that the fracture groove was not  
25 fractured, further prove with engineering certainty Mr. Shalaby’s injuries were caused  
26 by a defective cylinder.  
27

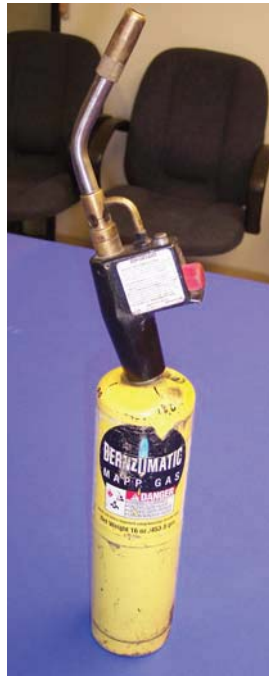
15  
16 (c) Consistent with the fact that the bushing area was the area of breach as  
17 shown in the exemplars in fig. 10 and 11 below (taken from the "Gertz"  
18 and "Vanderlinde" cases posted at [www.bernzomaticinjuries.com](http://www.bernzomaticinjuries.com) ,  
19 located under the "lawsuits" tab), it would have been impossible for Mr.  
20 Shalaby to have been holding the assembly by the torch handle itself. If  
21 the assembly were held by the torch handle, any force applied to the  
22 torch tip would not be able to transfer to the bushing area, but would  
23 cease at the point of origin, the torch handle itself. This evidences  
24 establishes that Mr. Shalaby was holding the assembly by the yellow  
25 MAPP cylinder, consistent with his September 2008 recollection.  
26  
27  
28

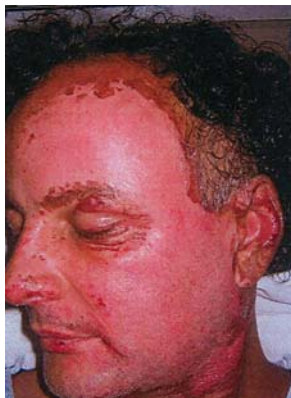
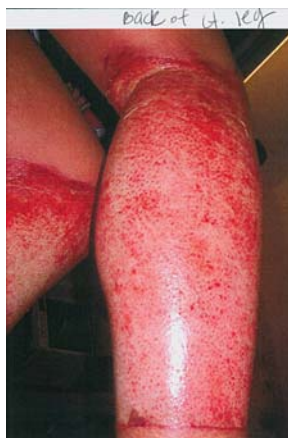
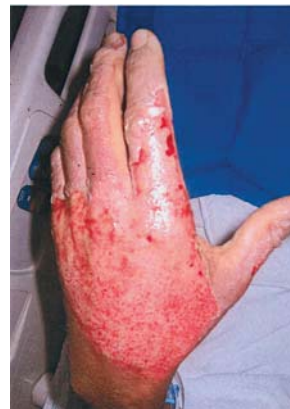
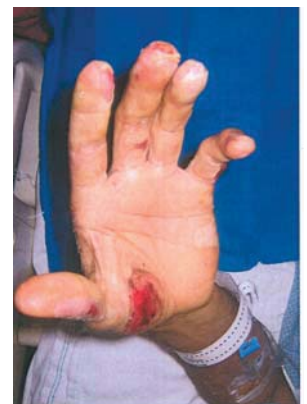
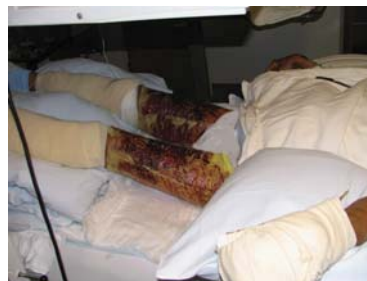
8. The defendants have expressed a theory, based on an alleged statement Mr. Shalaby made to a paramedic at the time of injury, that Mr. Shalaby had kicked the cylinder assembly into a campfire, and it exploded. I was unaware that photos of the actual injuries had existed prior to December 2008. Mr. Shalaby advises me that the hospital in San Diego had recently found photographs of his injuries, and he received the photos on or about November 6, 2008. I have examined the photos shown in figures 12-17 below.

9. Figures 12-16, and the overall magnitude of the injuries, indicate Mr. Shalaby was at the epicenter of the “ball of fire” which engulfed him from head to tow. Fig. 17 reveals that the inside of his right hand was not burned because it was protected from the flames by the cylinder, with exception of injury to the exact portion of his hand which was exposed (fig. 18). Figures 17 and 18 in particular indicate that the cylinder was in Mr. Shalaby’s hand at the moment of breach, while Defense expert Thomas Eager accurately explained that the MAPP gas cylinder would only breach when placed in a fire if a pressure relief valve located on top of the cylinder would have failed, and the injury would have been localized from only one direction, not circumferentially from head to toe. The recently discovered photos therefore disprove the defendants’ theory that the cylinder had been kicked, on grounds of impossibility, consistent with Defense Expert Thomas Eager’s opinion on this issue.<sup>1</sup>

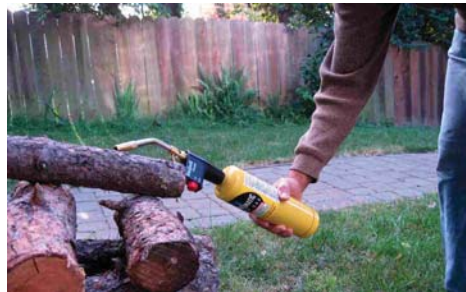
4  
5  
6  
7  
8  
9 fig. 19

1 2008, that he had tapped or nudged a piece of firewood at the moment of the  
2 explosion, while holding the cylinder substantially as shown in fig. 19 below, is  
3 wholly consistent with the evidence.
