**UNITED STATES COURT OF APPEALS  
FOR THE NINTH CIRCUIT**

**APPELLANTS' REQUEST FOR JUDICIAL NOTICE IN  
SUPPORT OF OPPOSITION TO MOTION TO STRIKE MOTION  
TO EXPEDITE APPEAL AND IN SUPPORT OF APPEAL**

**(Photos of failed cylinders from other cases)**

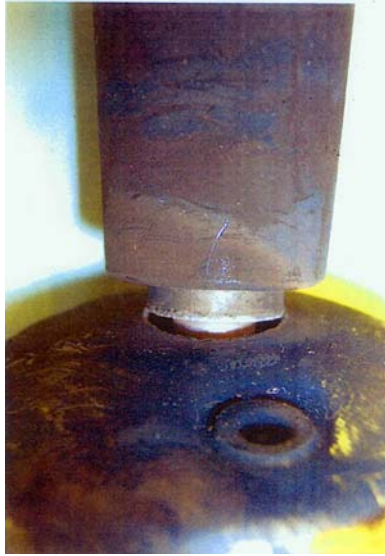
- 1 - Vanderlinde cylinder, closeup of failed brazed joint, located in the record at ER v4 p. 805 (Appellants' Excerpts of Record (ER)), with corresponding declaration of Mr. Vanderlinde at ER v.2 p.354 (see attached Exhibit 1, Pacer, for full case name and number);
- 2 - Vanderlinde cylinder, full view
- 3 - Glenn cylinder, from Glenn v. Newell Operating Company dba Bernzomatic Corporation, Superior Court of California, Ventura County, case number 56-

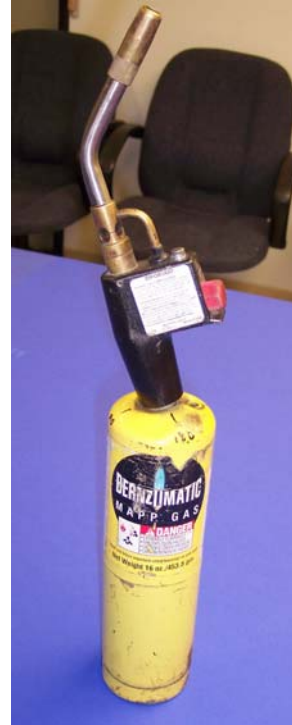
3 - Glenn

2007-00285785-CU-PL-VTA, located in the record at ER v4 p. 806.;

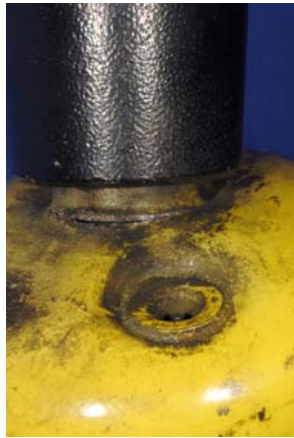
4 - Glenn cylinder, closeup of brazed joint (Doc. 93-15);

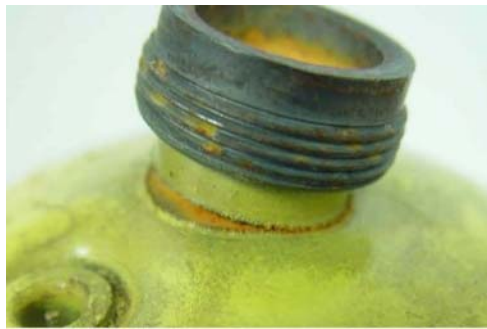
5 - Barrett cylinder (Pacer, Exhibit 1), located at ER v4 p. 807;

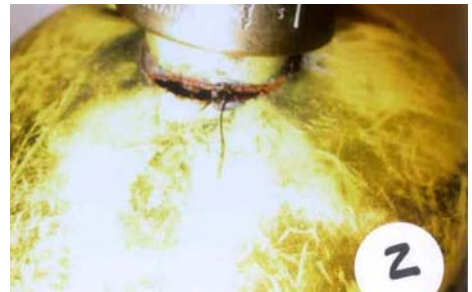
6 - Welch cylinder (Pacer, Exhibit 1), located at ER v4 p. 809;

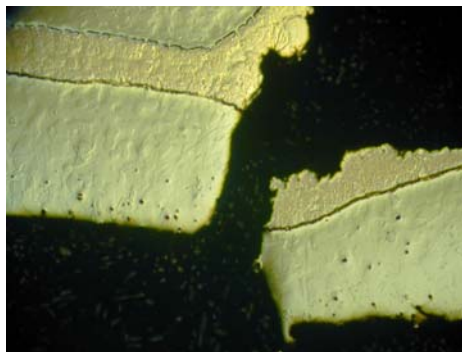
7 - New case discovered 10/26/09, after opening brief was filed, shows failure of a MAPP gas cylinder produced by the same defendant/Appellees, showing the split at both the brazing compound and the parent metal - please see Shalaby declaration below;

(closeup of split on brazing and on parent metal)

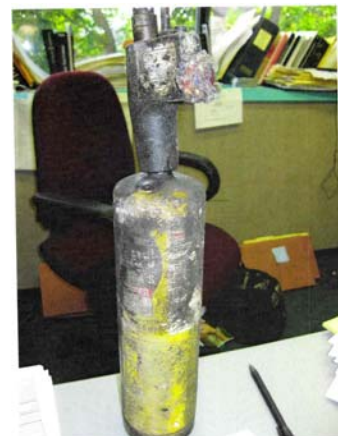
8 - Tucker, appeared on Pacer after AOB was filed

8 - Tucker cylinder, discovered 12/09 after Appellant's reply brief was filed, appeared on Pacer 12/09 - please see Shalaby declaration below.
